RESOLUTION NO. 11972

RESOLUTION OF THE PLANNING COMMISSION OF THE CITY OF SANTA ROSA ADOPTING A MITIGATED NEGATIVE DECLARATION, INCLUDING A MITIGATION MONITORING PROGRAM, FOR RECESS SELF-STORAGE (A MIXED-USE DEVELOPMENT), LOCATED AT 4200 AND 4224 SONOMA HIGHWAY; ASSESSOR'S PARCEL NUMBERS 032-010-005 AND 032-010-023; FILE NO. PRJ18-050

The Recess Storage Project (Project) will construct a four-story, 124,000-square foot, self-storage facility and two multi-family residential structures; one structure will have six dwelling units and one structure will have eight dwelling units. The Project entitlements include a Prezoning to the CG (General Commercial) zoning district for Annexation to the City of Santa Rosa; a Tentative Parcel Map to subdivide an approximately 2.68-acre parcel into three separate lots; a minor Conditional Use Permit for a self-storage facility and multi-family housing; a Design Review for the construction of a commercial building greater than 10,000 square feet and attached housing; and a Hillside Development Permit for development on slopes greater than 10 percent.

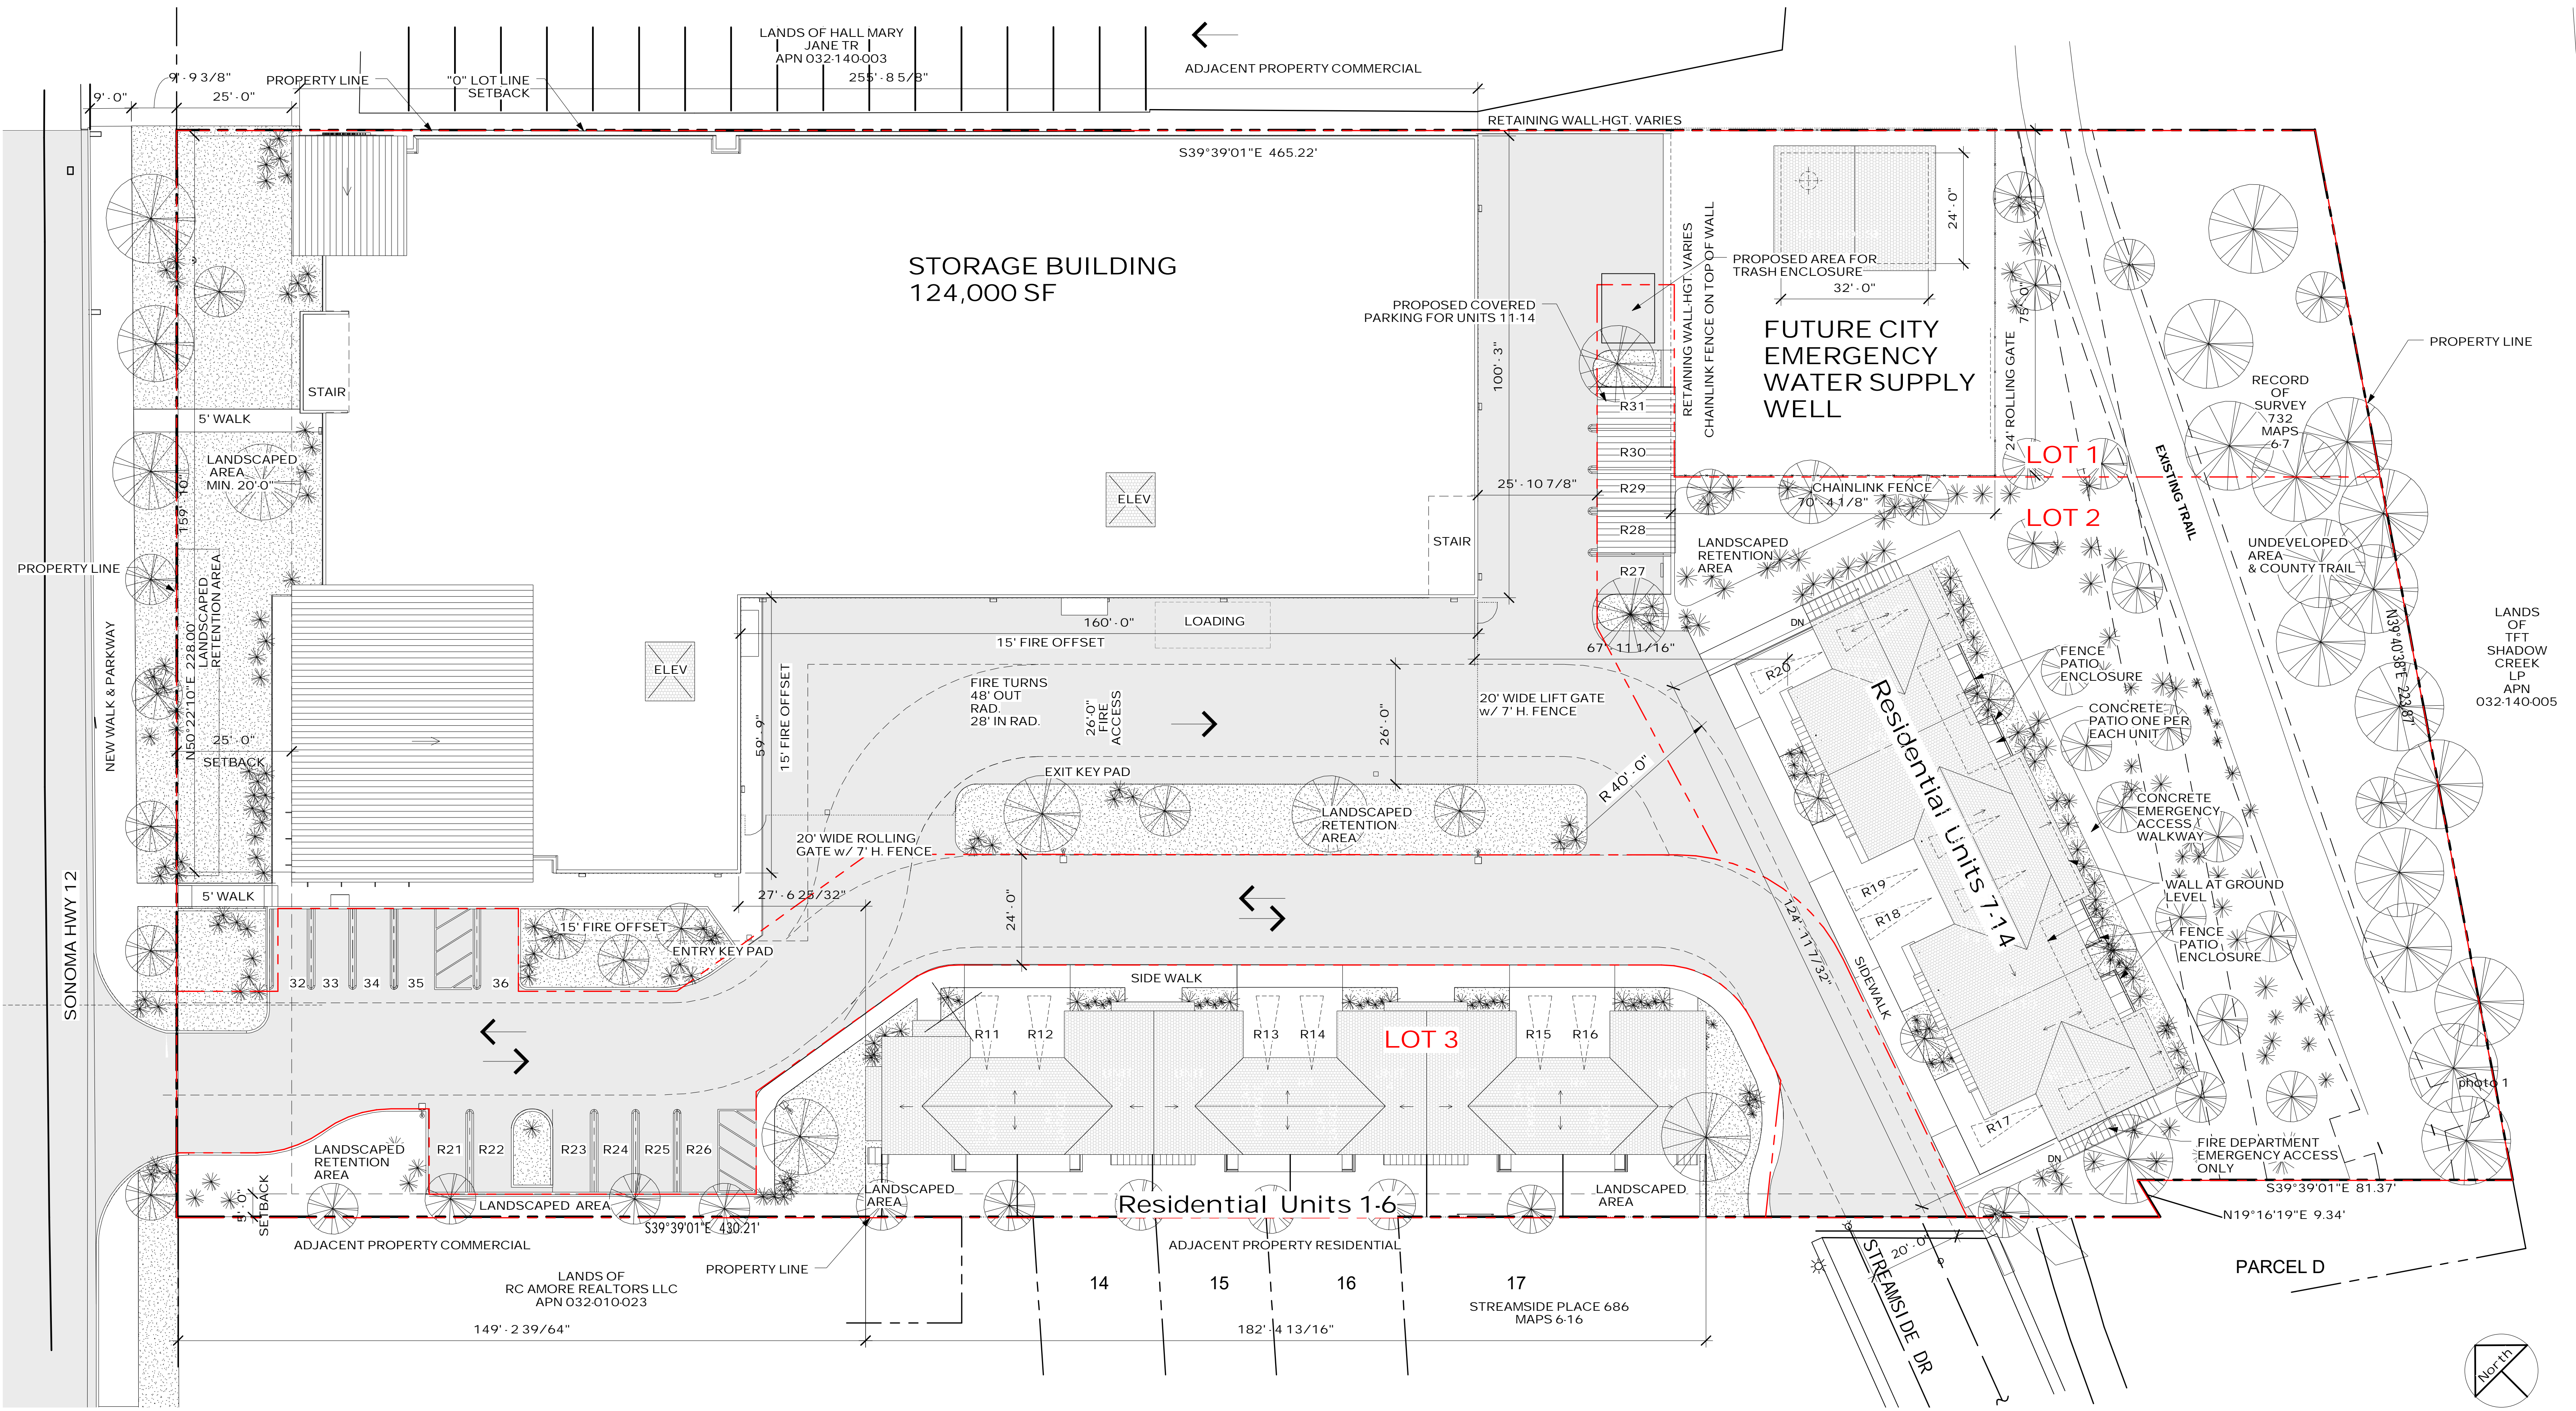
Site Plan/ Roof Plan

Scale 1/16" = 1'-0"

As shown in Figure 2 Site Plan, the storage structure will be setback 25 feet from the property line. The residential structure on the southwestern property line will be setback approximately 150 feet from the interior side of the sidewalk, which will not readily visible from Sonoma Highway. The Project will be setback approximately 150 feet from Santa Rosa Creek (Figure 4). All three structures will have a variety of exterior siding materials, varied roof lines, and landscaping.

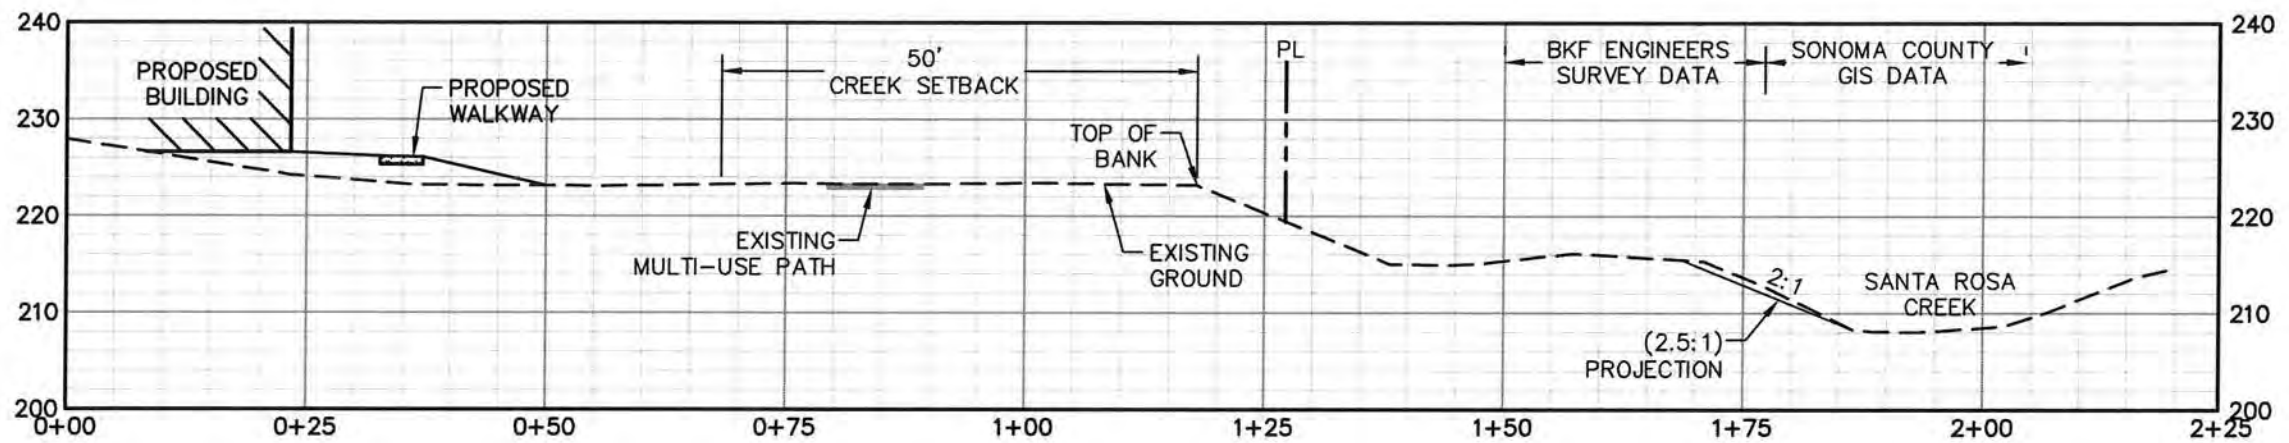
SECTION 1
 H: 1"=20'
 V: 1"=20'

CREEK SETBACK SECTIONS

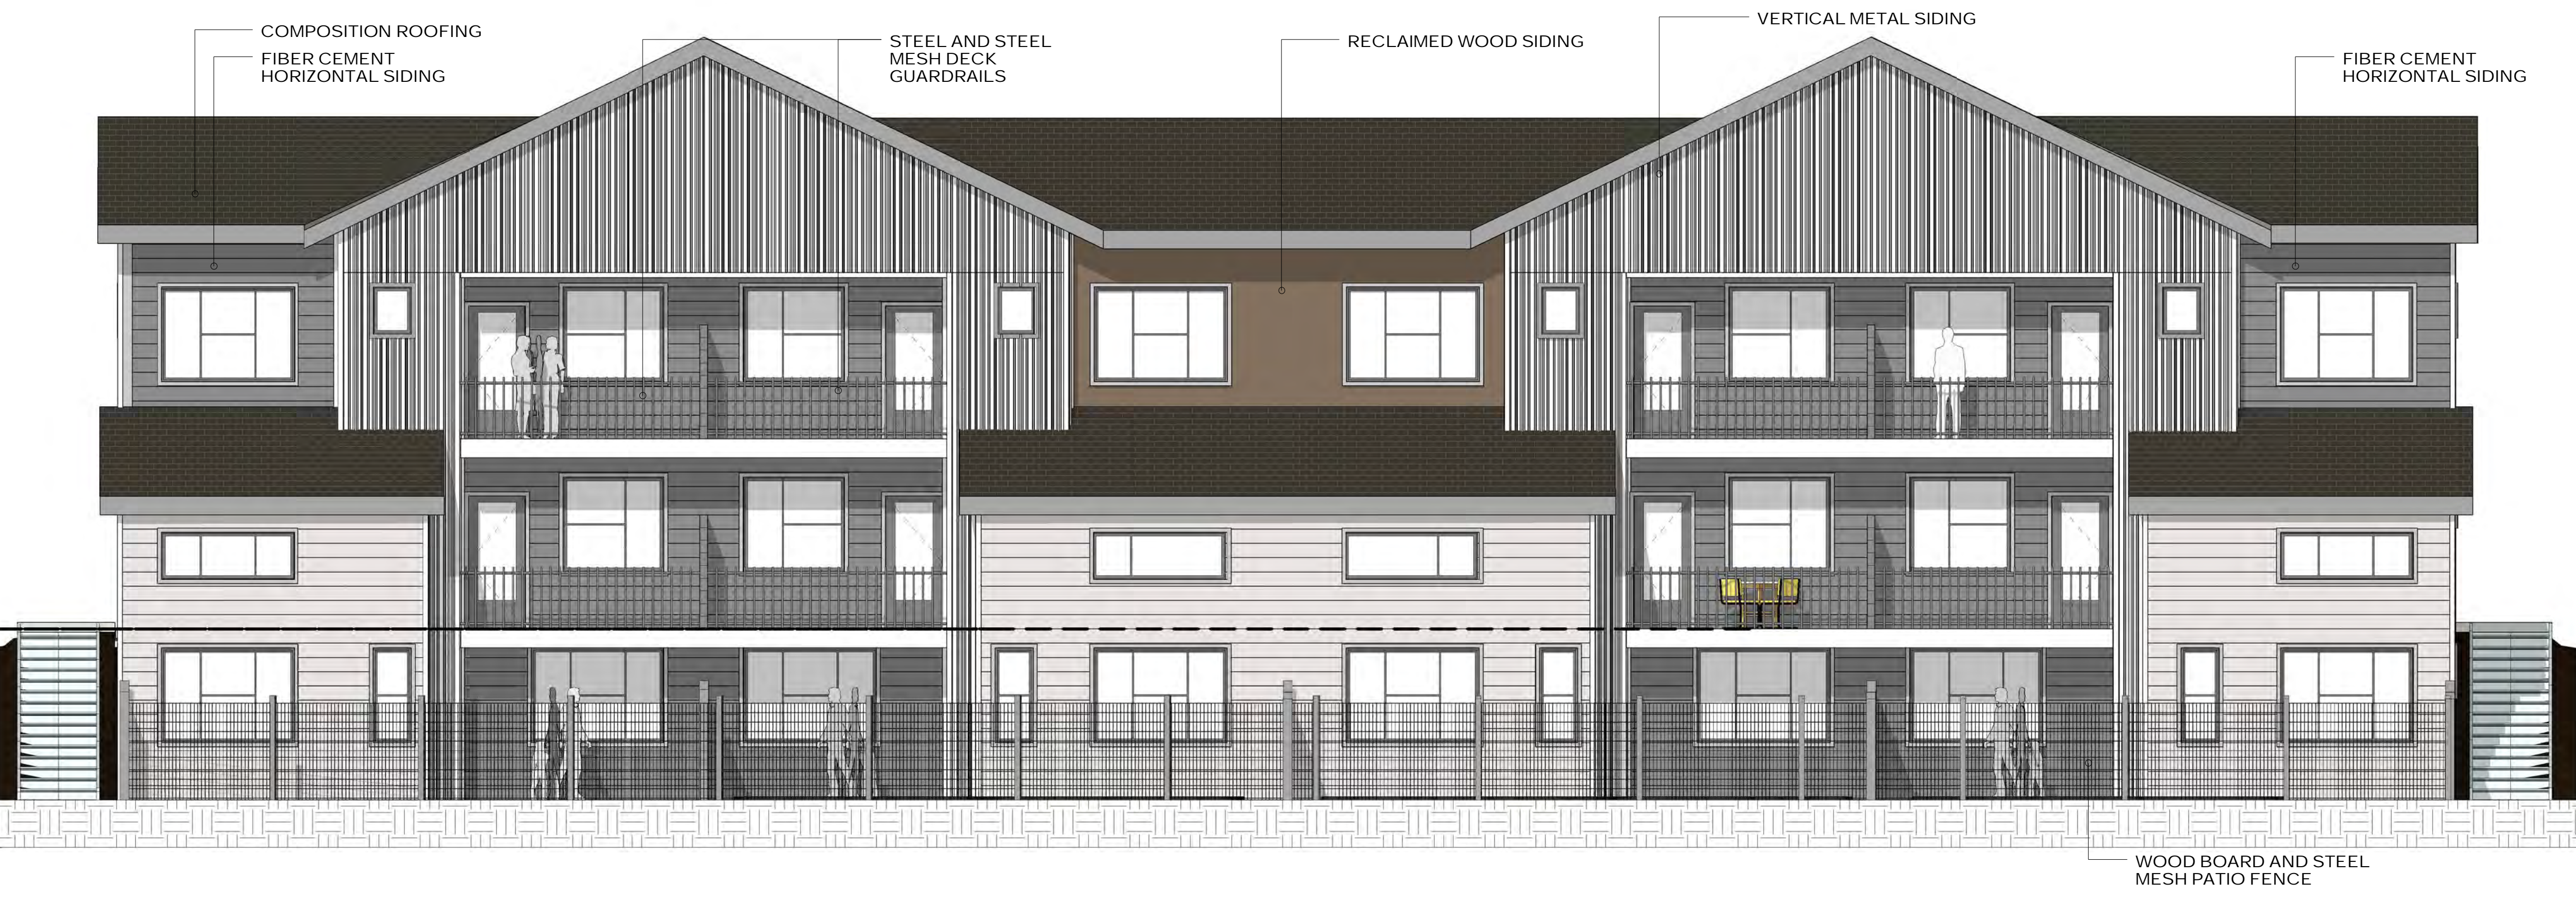
Residential Units 7-14 East Elevation
Scale 3/16" = 1'-0"

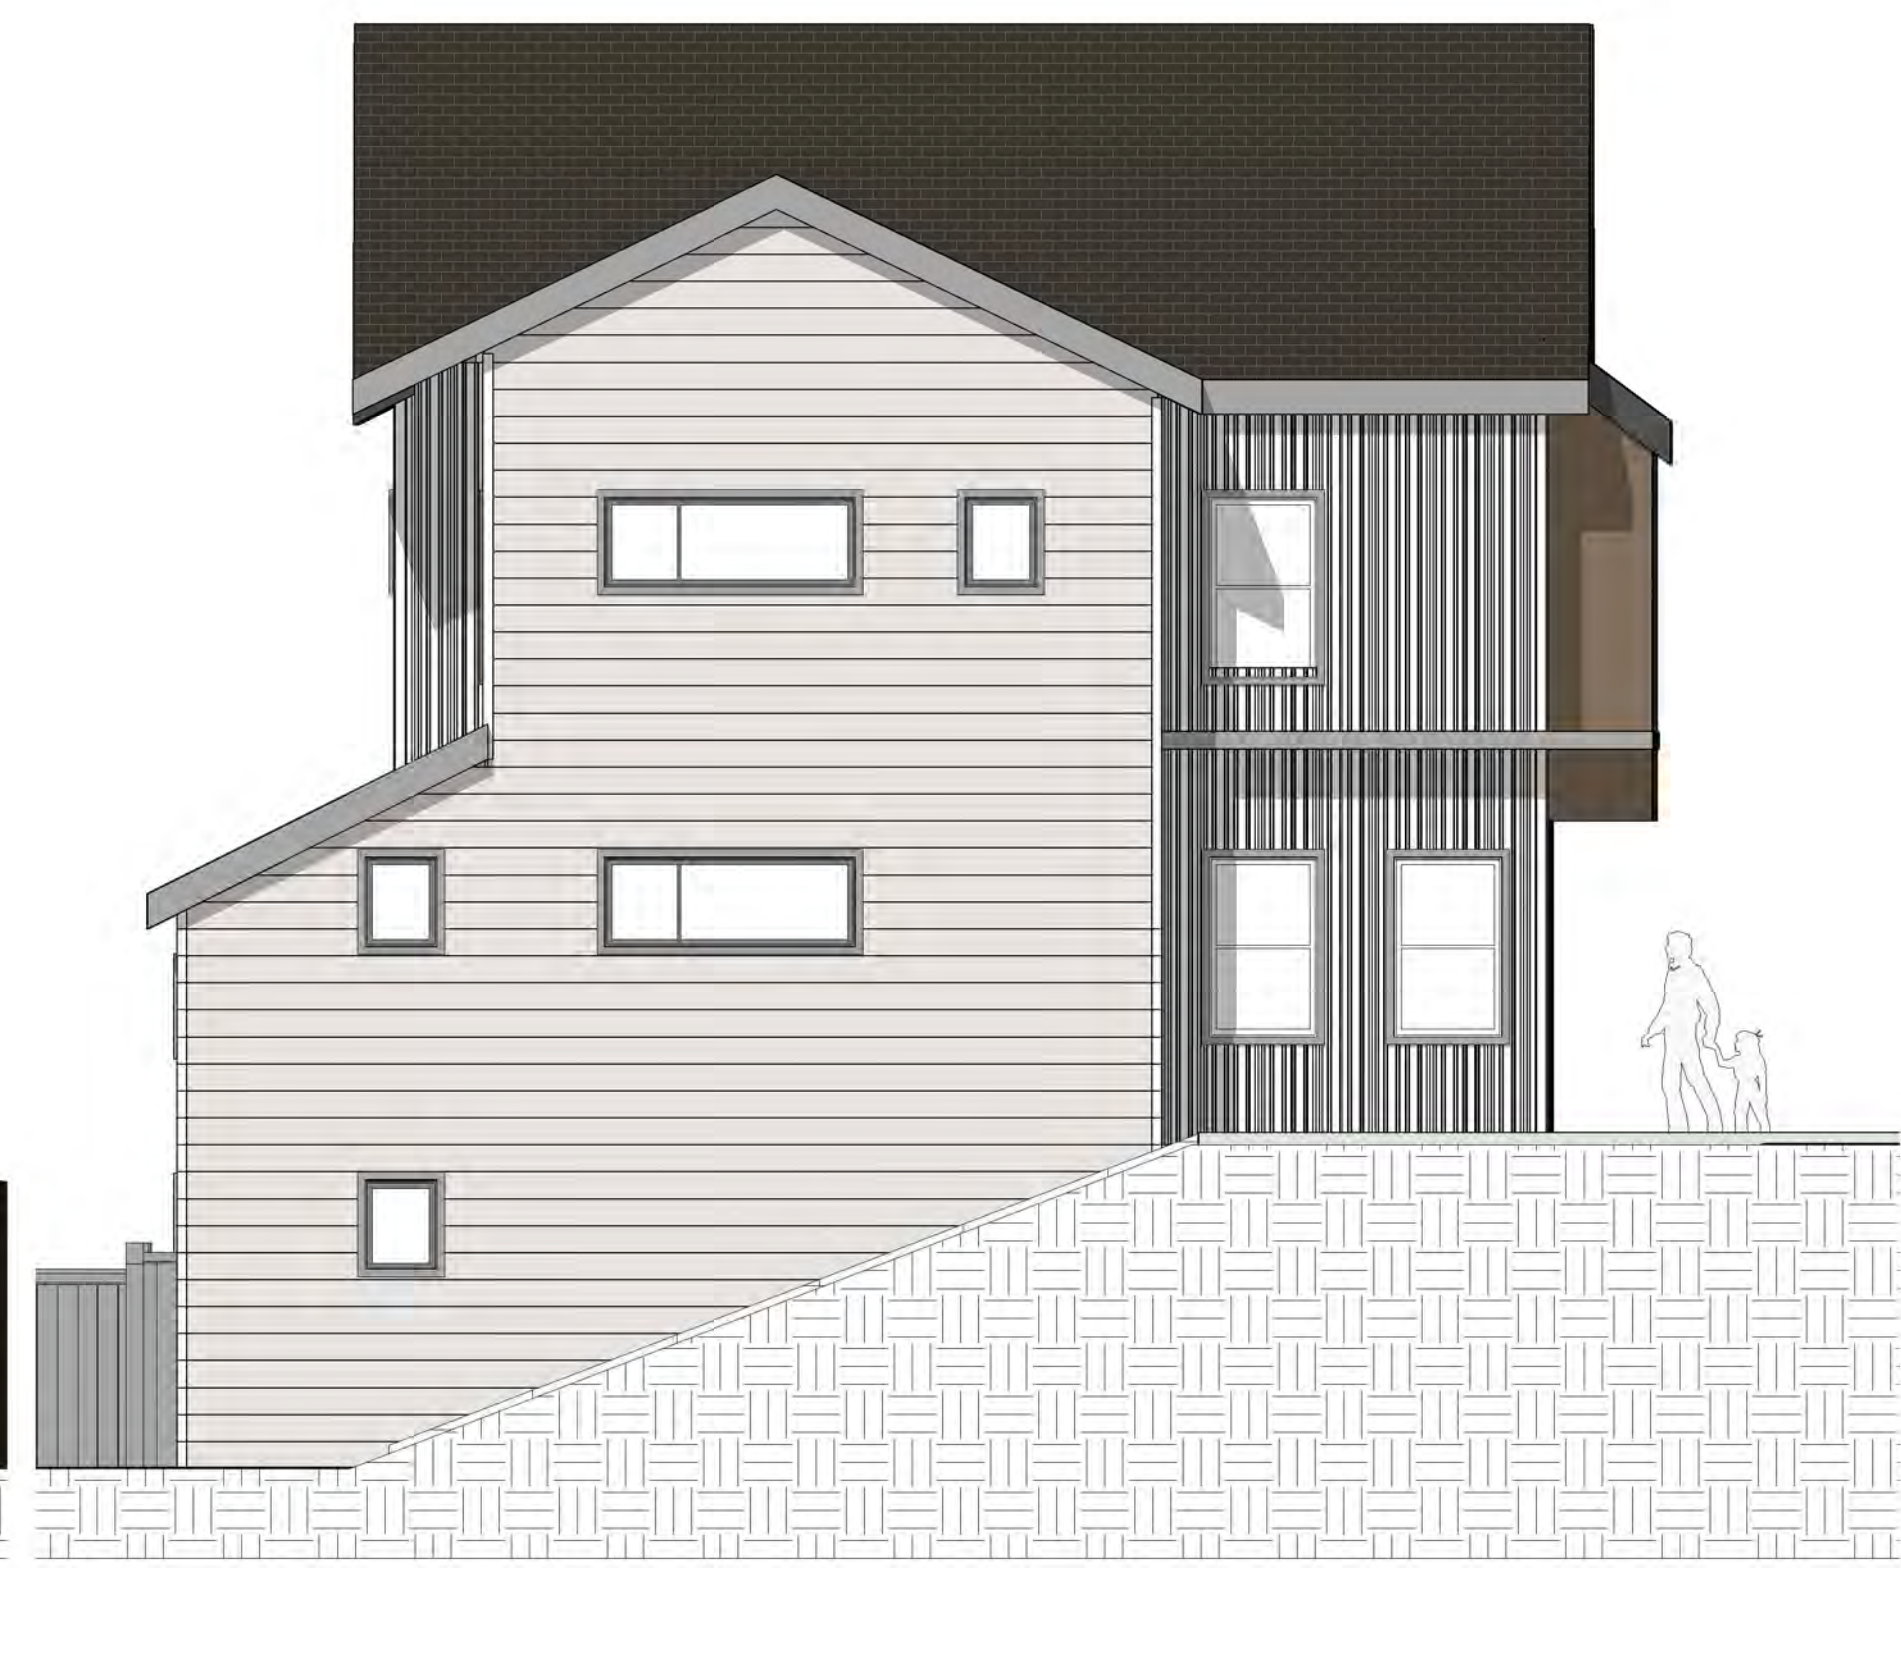
Residential Units 7-14 North Elevation
Scale 3/16" = 1'-0"

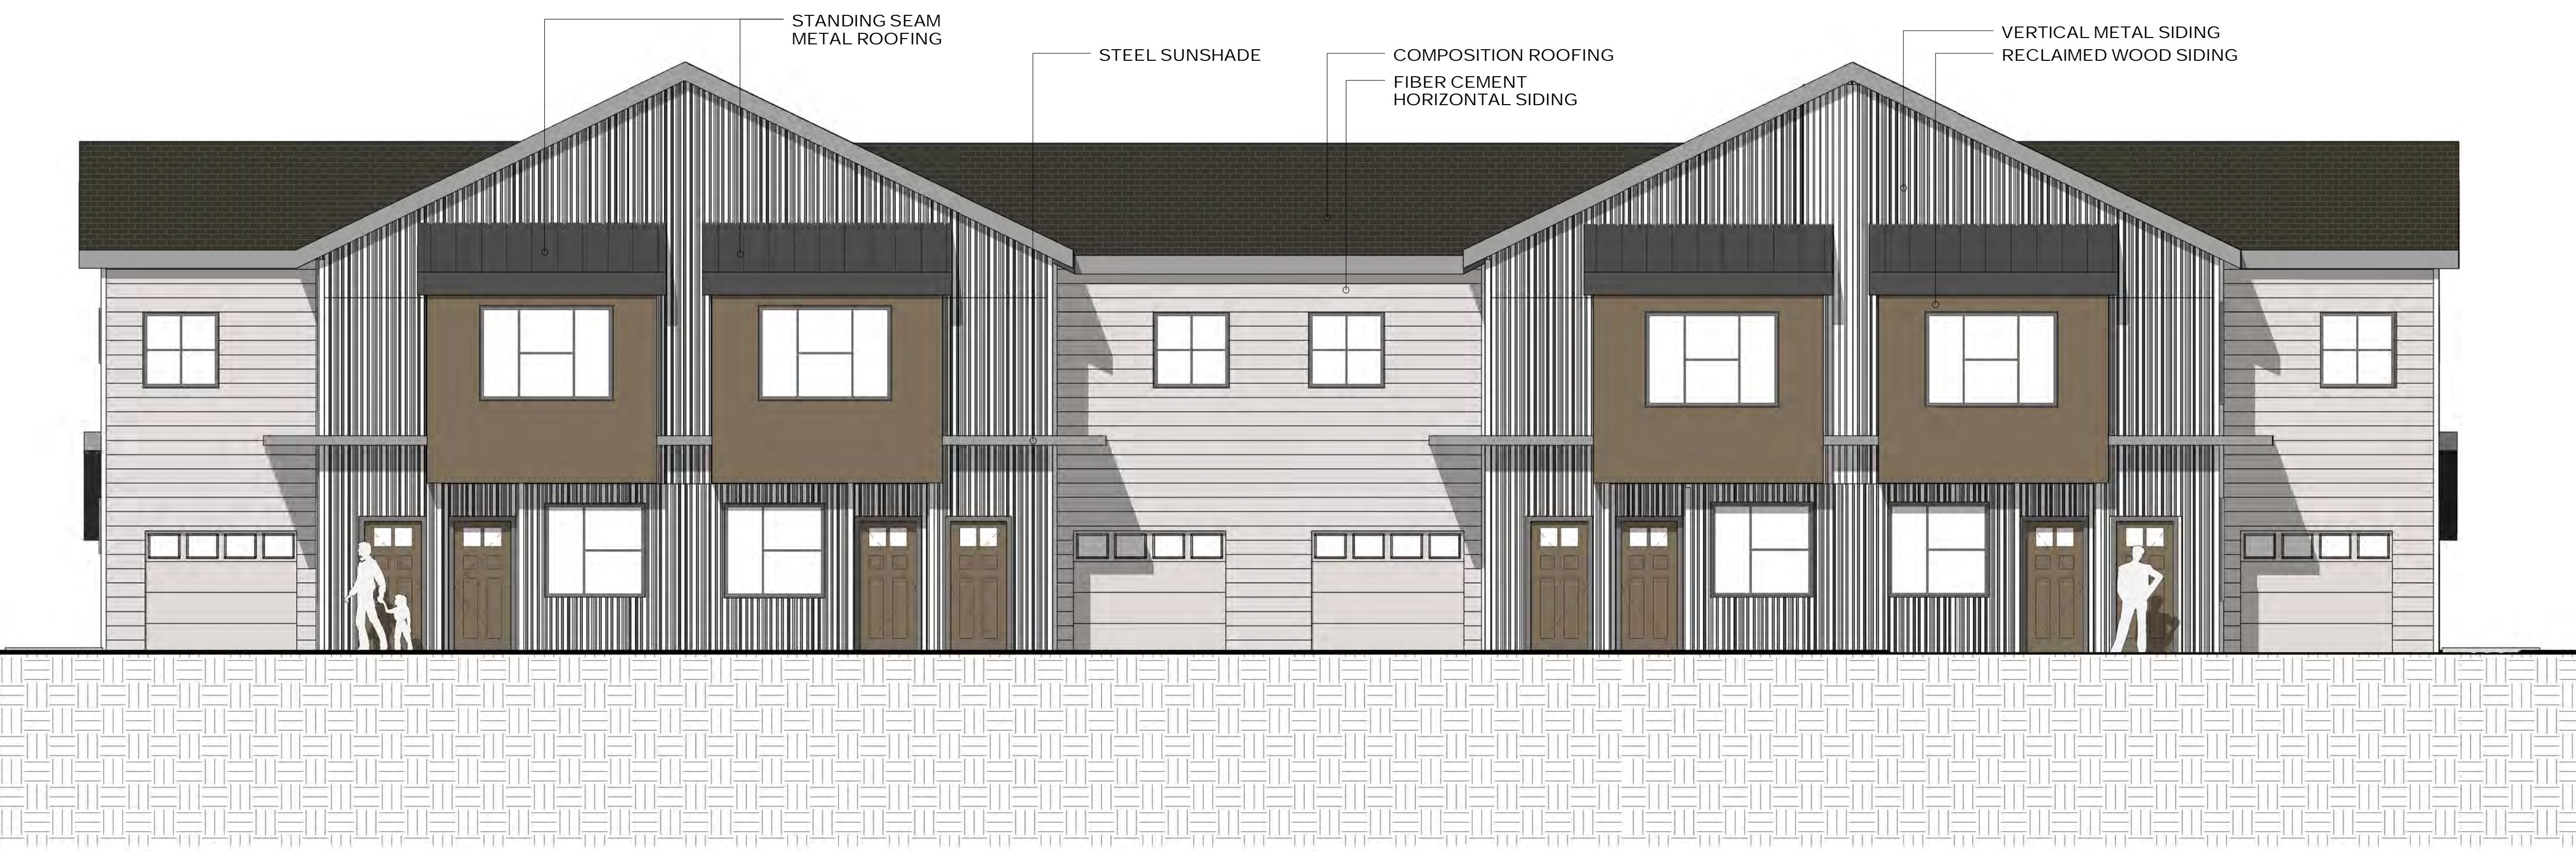
Residential Units 7-14 West Elevation
Scale 3/16" = 1'-0"

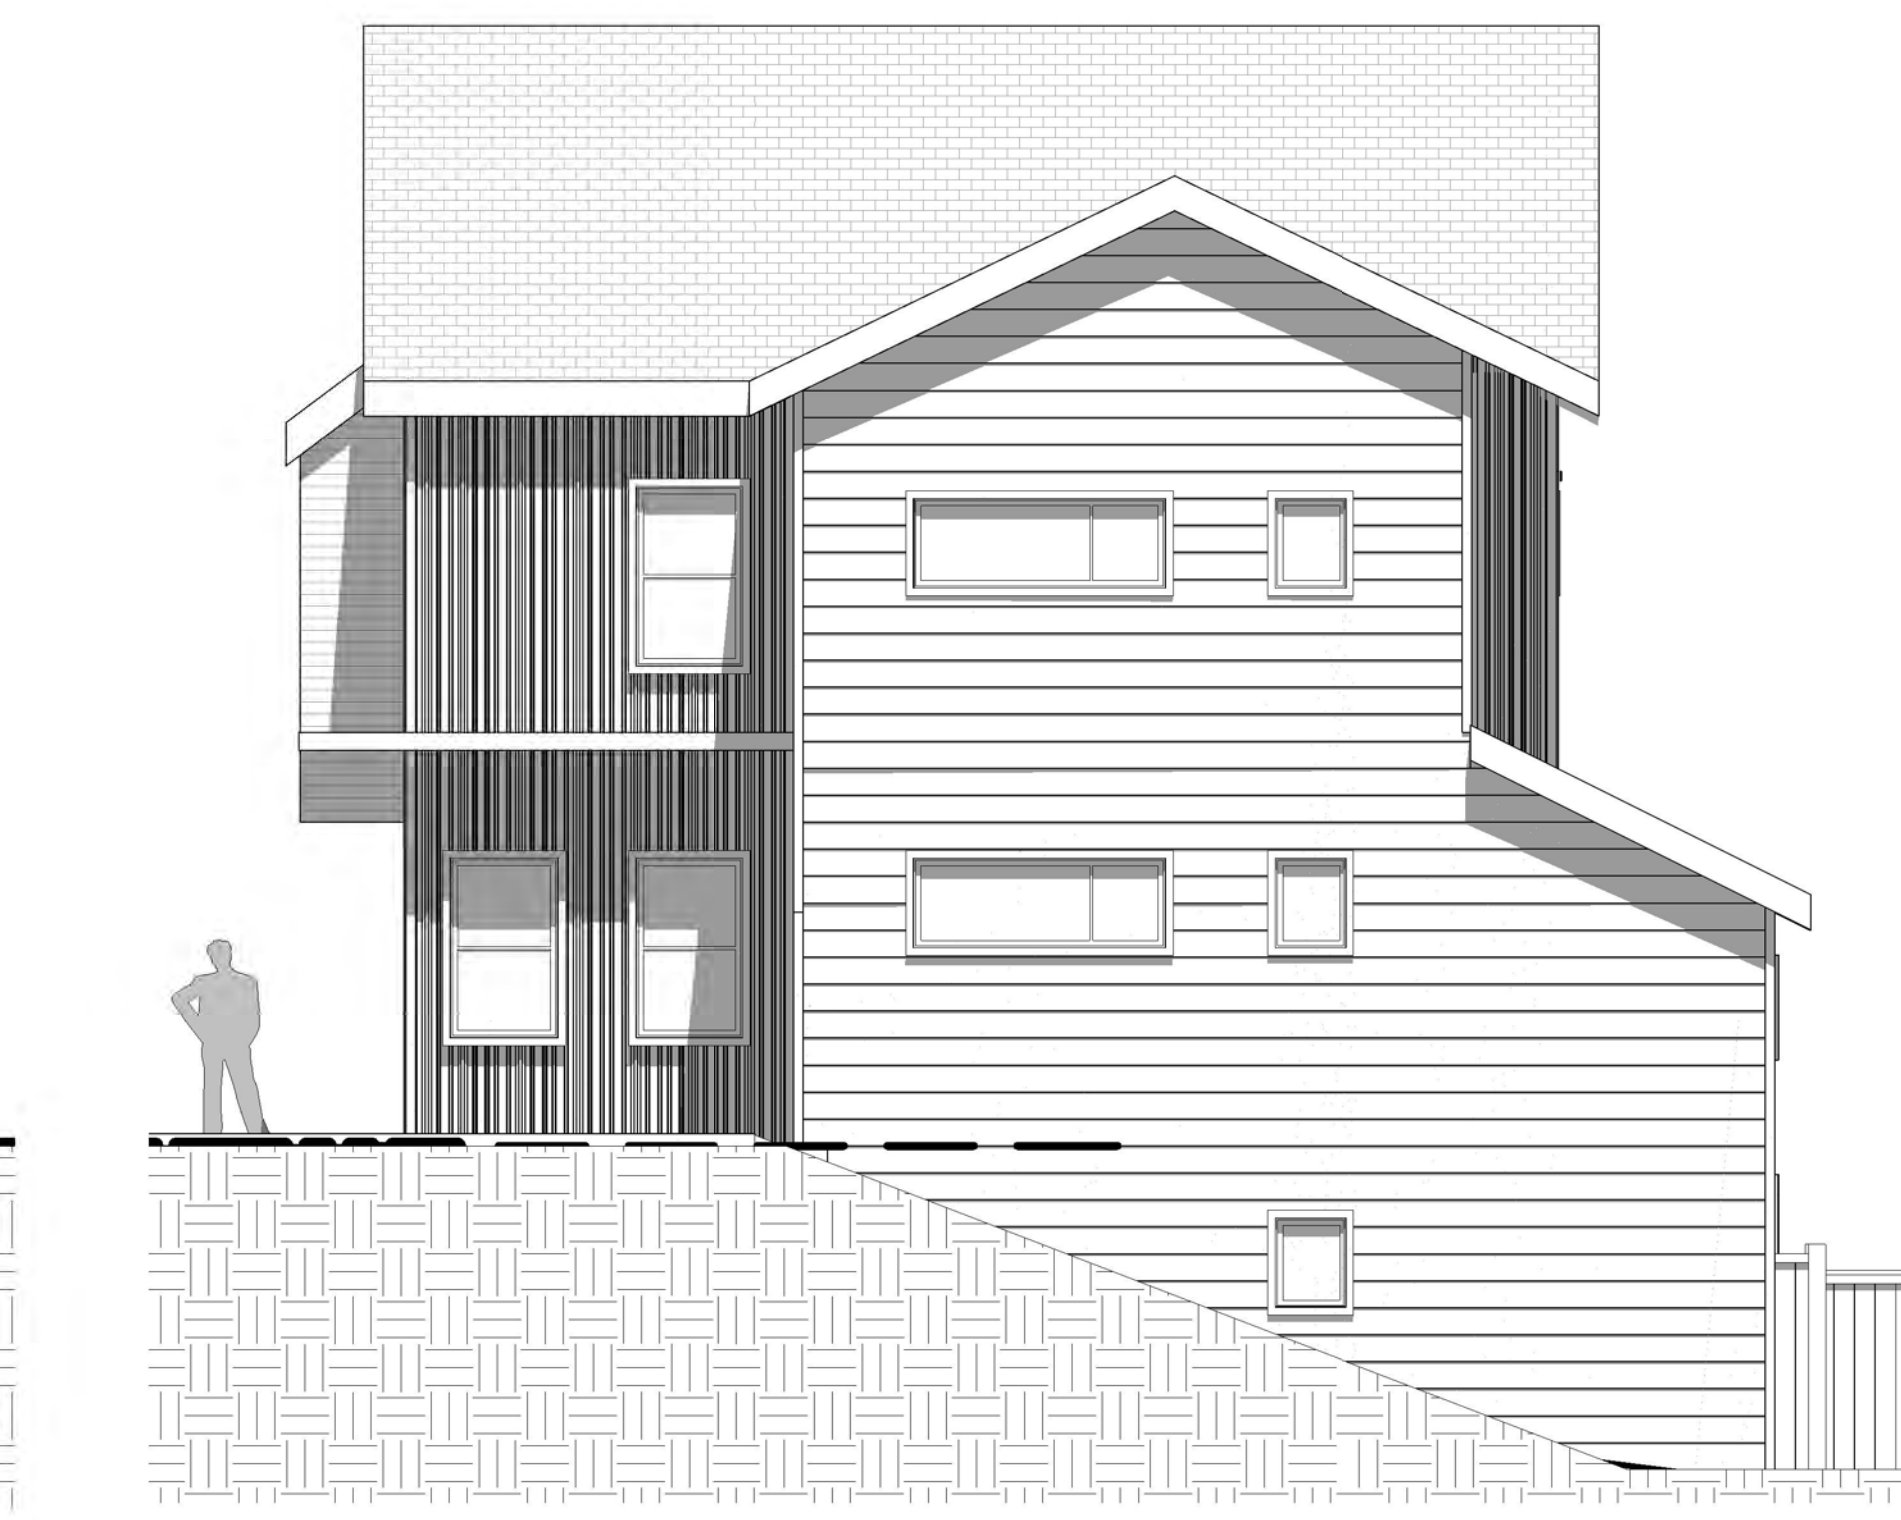
Residential Units 7-14 South Elevation
Scale 3/16" = 1'-0"

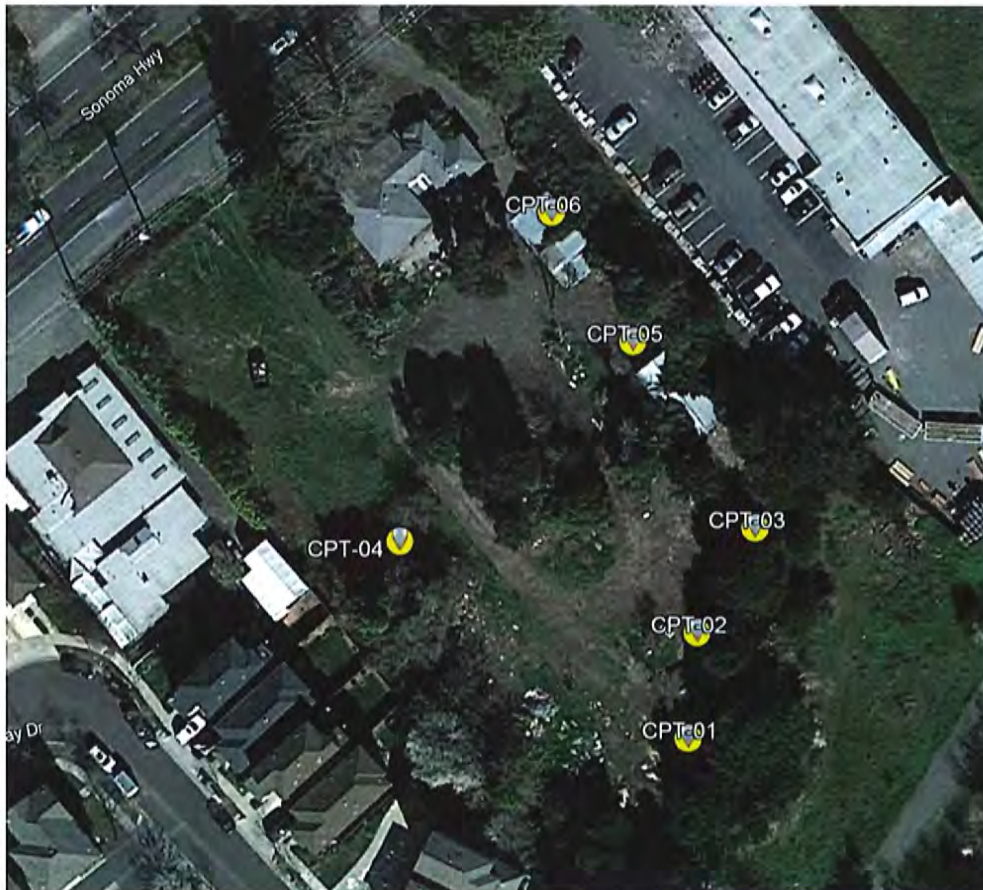
An aerial overview from Google Earth including the CPT locations is presented below.

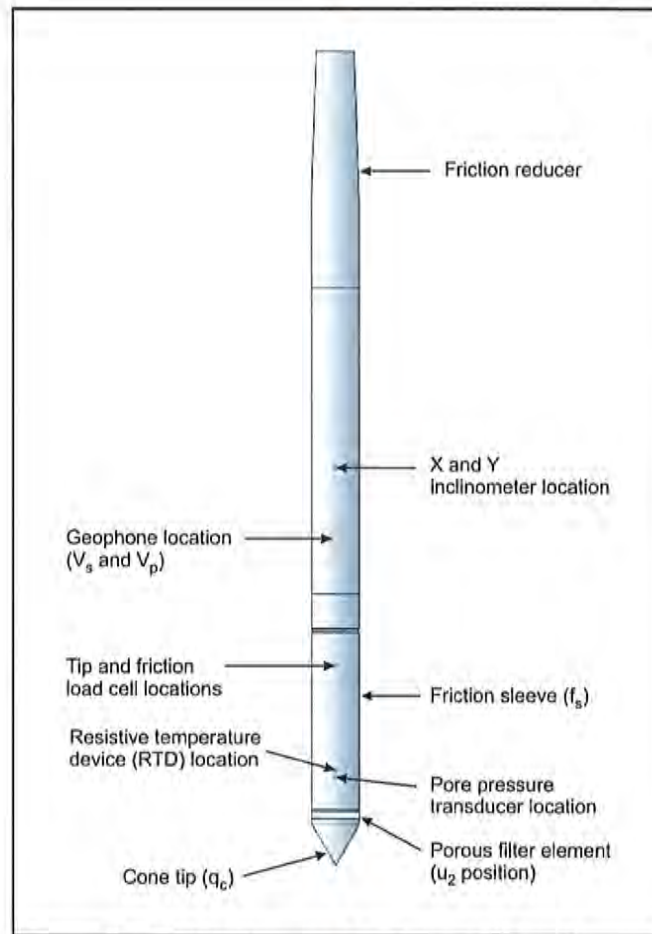
Figure CPTu. Piezocone Penetrometer (15 cm²)

The piezocone penetrometers are manufactured with dimensions, tolerances and sensor characteristics that are in general accordance with the current ASTM D5778 standard. Our calibration criteria also meet or exceed those of the current ASTM D5778 standard. An illustration of the piezocone penetrometer is presented in Figure CPTu.

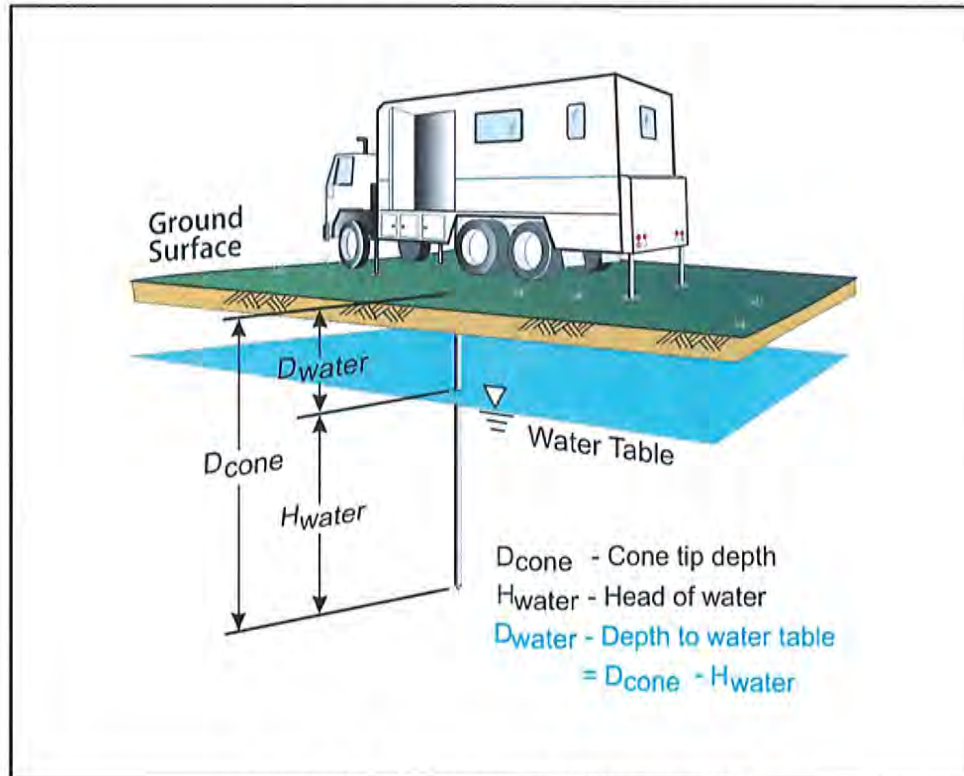
Figure PPD-1. Pore pressure dissipation test setup

The cone penetration test is halted at specific depths to carry out pore pressure dissipation (PPD) tests, shown in Figure PPD-1. For each dissipation test the cone and rods are decoupled from the rig and the data acquisition system measures and records the variation of the pore pressure (u) with time (t).

Pore pressure dissipation data can be interpreted to provide estimates of ground water conditions, permeability, consolidation characteristics and soil behavior.

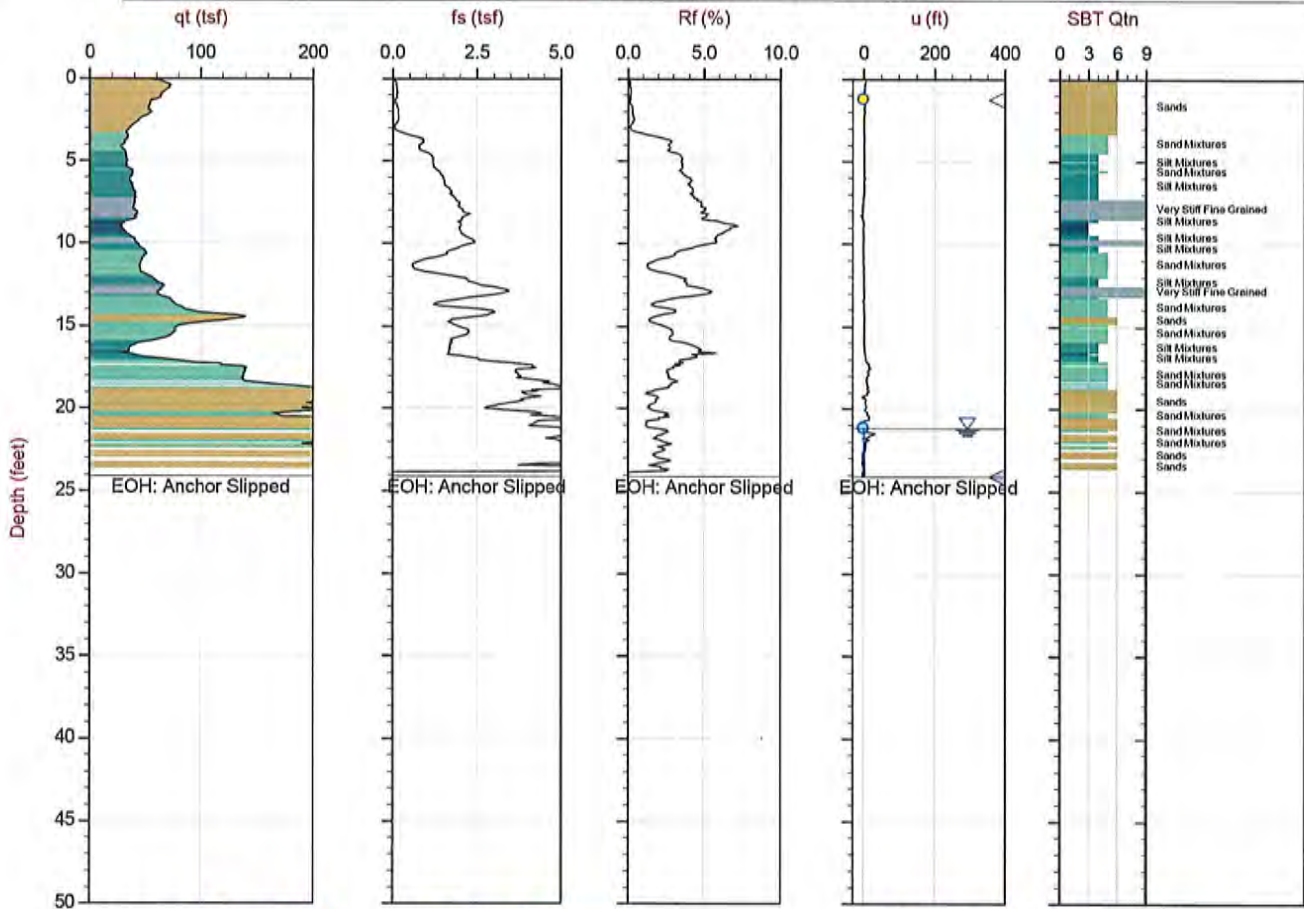
Sounding: CPT-01
 Cone: 443:T1500F15U500

Max Depth: 7.350 m / 24.11 ft
 Depth Inc: 0.025 m / 0.082 ft
 Avg Int: Every Point

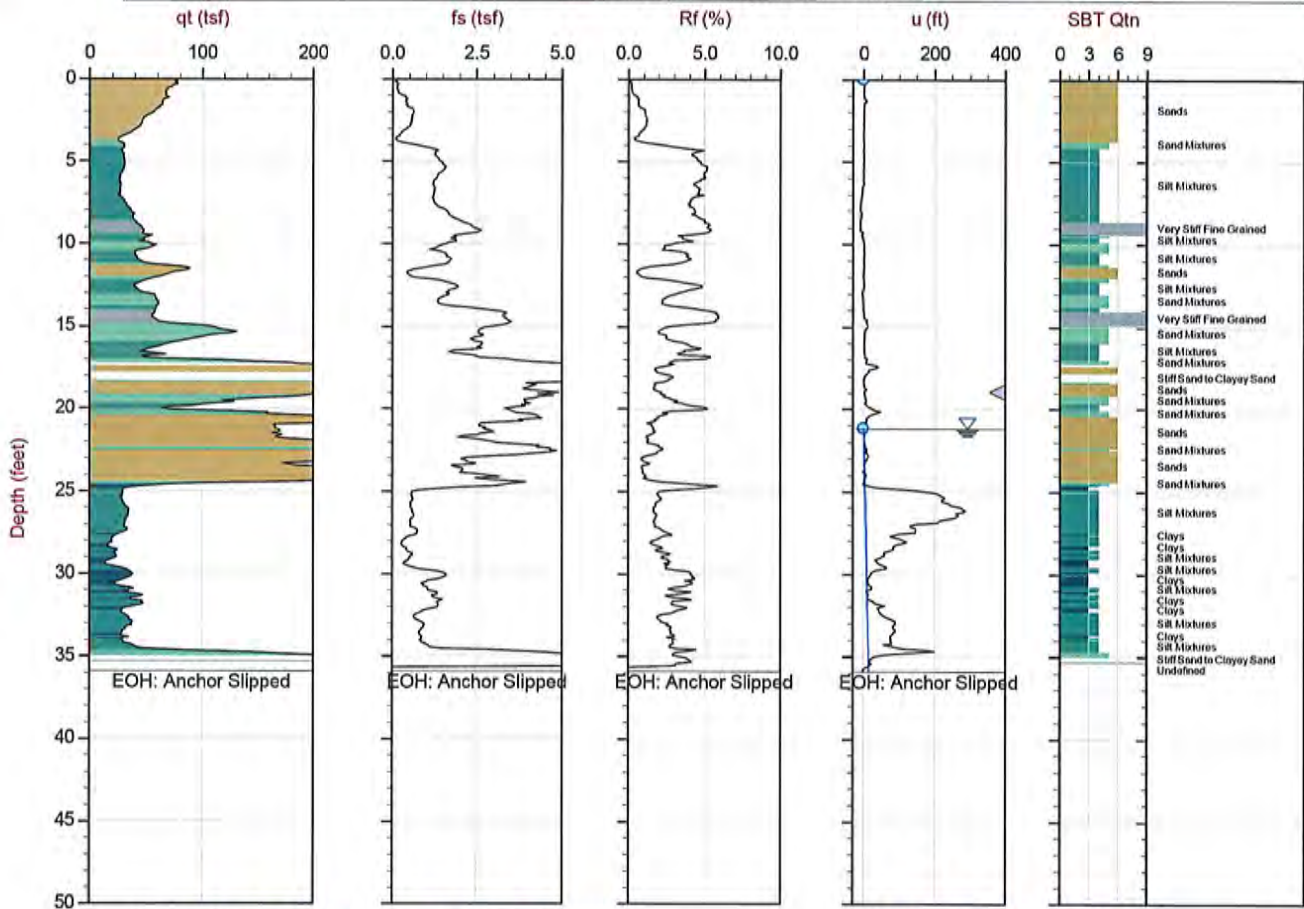
Sounding: CPT-02
 Cone: 443:T1500F15U500

Max Depth: 10.950 m / 35.92 ft
 Depth Inc: 0.025 m / 0.082 ft
 Avg Int: Every Point

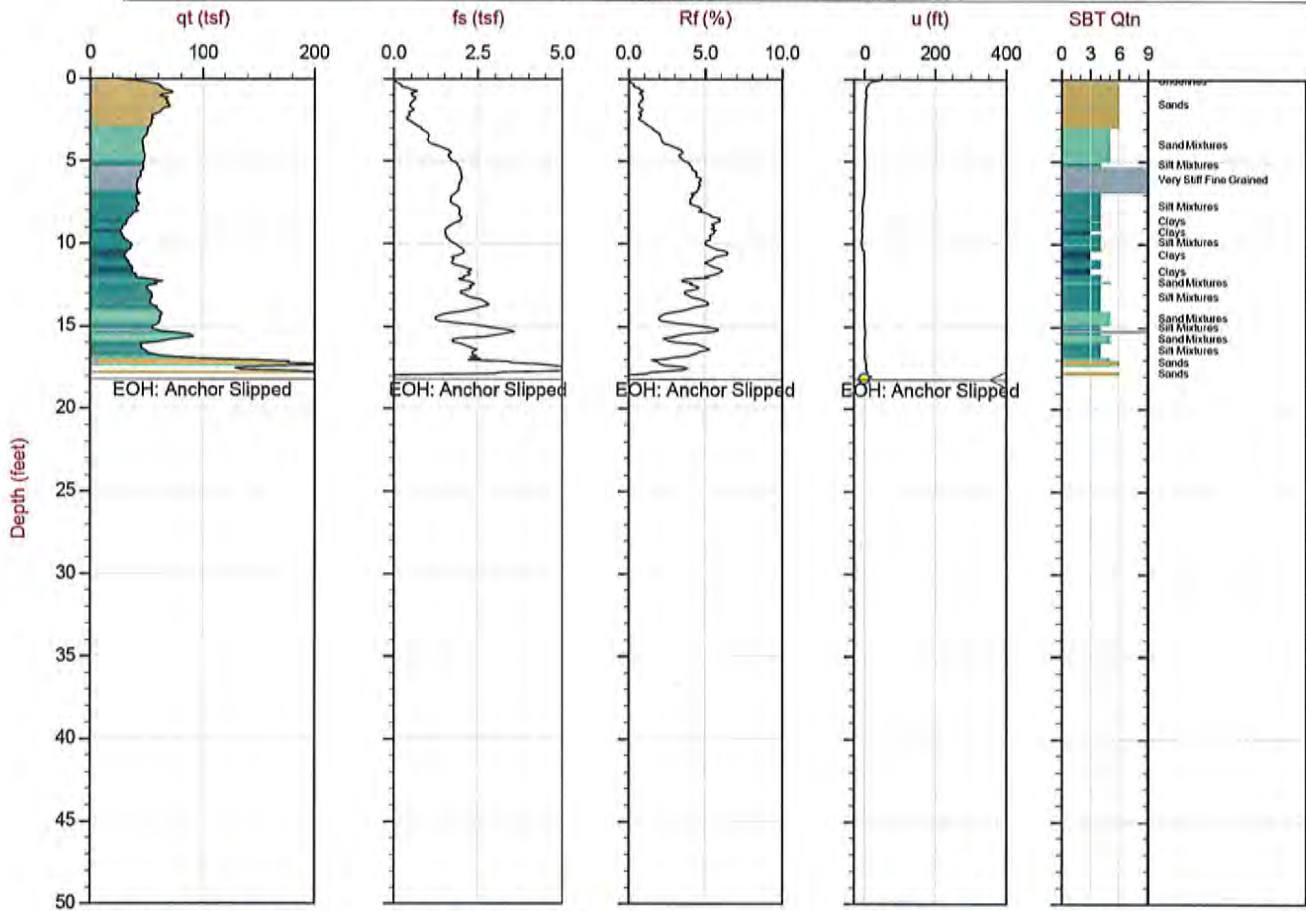
Sounding: CPT-03
 Cone: 443:T1500F15U500

Max Depth: 5.550 m / 18.21 ft
 Depth Inc: 0.025 m / 0.082 ft
 Avg Int: Every Point

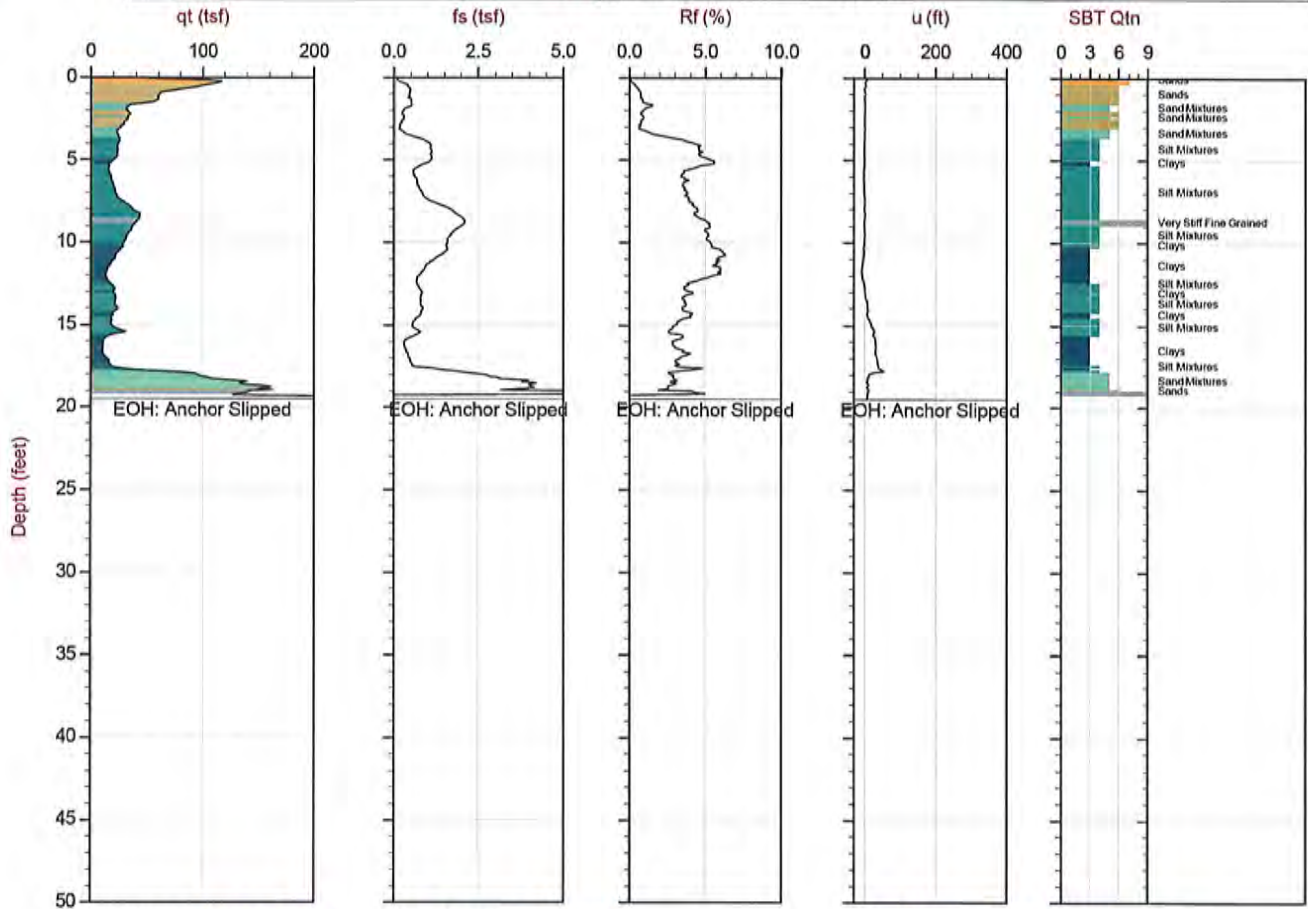
Sounding: CPT-05
 Cone: 443:T1500F15U500

Max Depth: 5.950 m / 19.52 ft
 Depth Inc: 0.025 m / 0.082 ft
 Avg Int: Every Point
