RESOLUTION NO. 11972

RESOLUTION OF THE PLANNING COMMISSION OF THE CITY OF SANTA ROSA ADOPTING A MITIGATED NEGATIVE DECLARATION, INCLUDING A MITIGATION MONITORING PROGRAM, FOR RECESS SELF-STORAGE (A MIXED-USE DEVELOPMENT), LOCATED AT 4200 AND 4224 SONOMA HIGHWAY; ASSESSOR'S PARCEL NUMBERS 032-010-005 AND 032-010-023; FILE NO. PRJ18-050

The Recess Storage Project (Project) will construct a four-story, 124,000-square foot, self-storage facility and two multi-family residential structures; one structure will have six dwelling units and one structure will have eight dwelling units. The Project entitlements include a Prezoning to the CG (General Commercial) zoning district for Annexation to the City of Santa Rosa; a Tentative Parcel Map to subdivide an approximately 2.68-acre parcel into three separate lots; a minor Conditional Use Permit for a self-storage facility and multi-family housing; a Design Review for the construction of a commercial building greater than 10,000 square feet and attached housing; and a Hillside Development Permit for development on slopes greater than 10 percent.

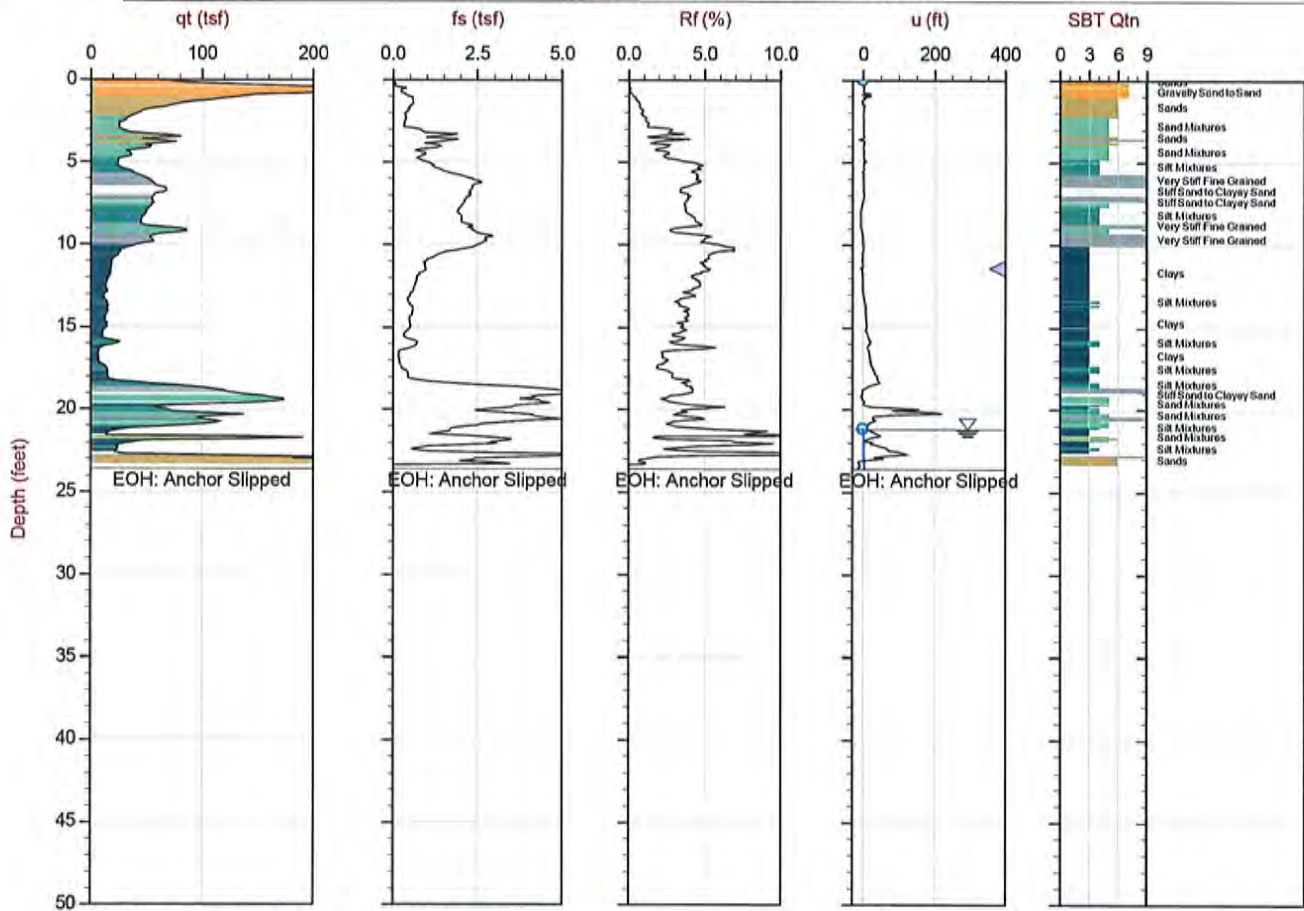
Sounding: CPT-06
 Cone: 443:T1500F15U500

Max Depth: 7.200 m / 23.62 ft
 Depth Inc: 0.025 m / 0.082 ft
 Avg Int: Every Point

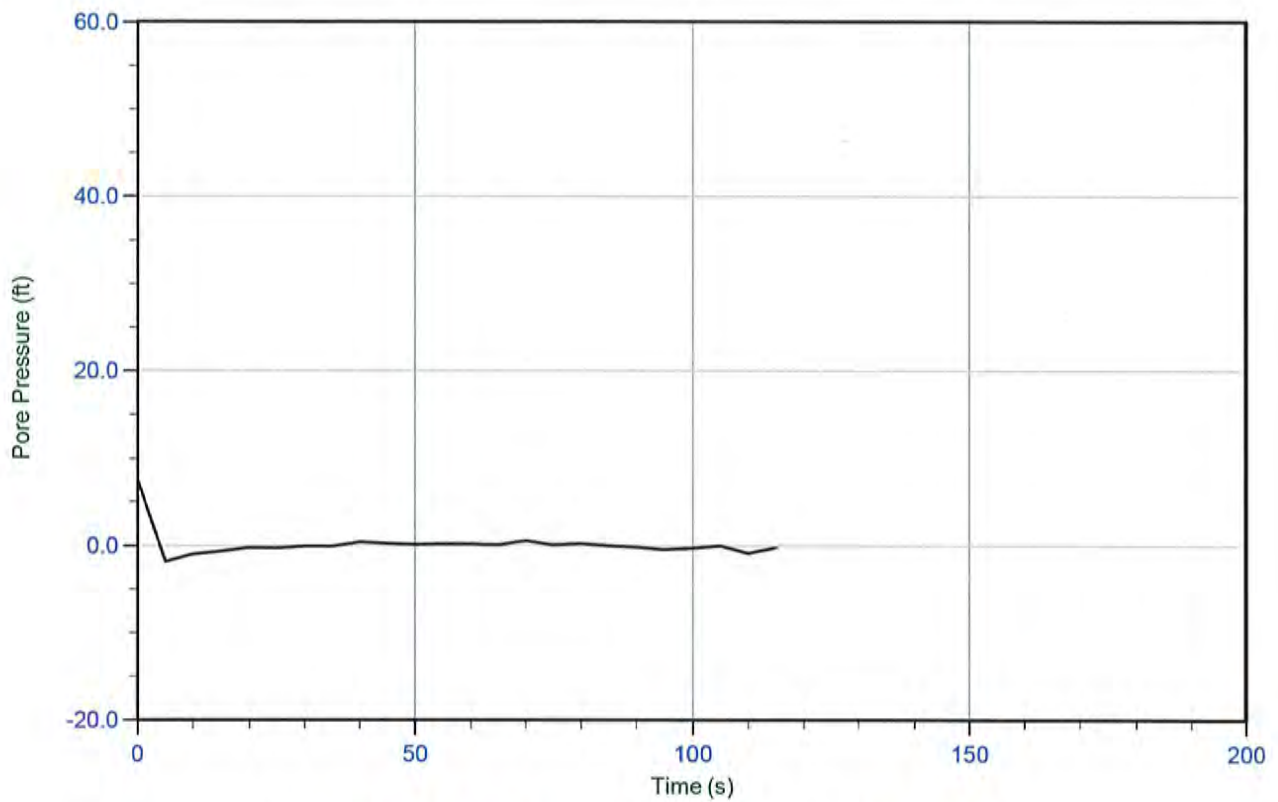
Sounding: CPT-03
Cone: 443:T1500F15U500 Area=15 cm²

Trace Summary: Filename: 18-56099_CP03.PPF U Min: -1.8 ft WT: 5.550 m / 18.208 ft
Depth: 5.550 m / 18.208 ft U Max: 7.4 ft Ueq: 0.0 ft
Duration: 115.0 s

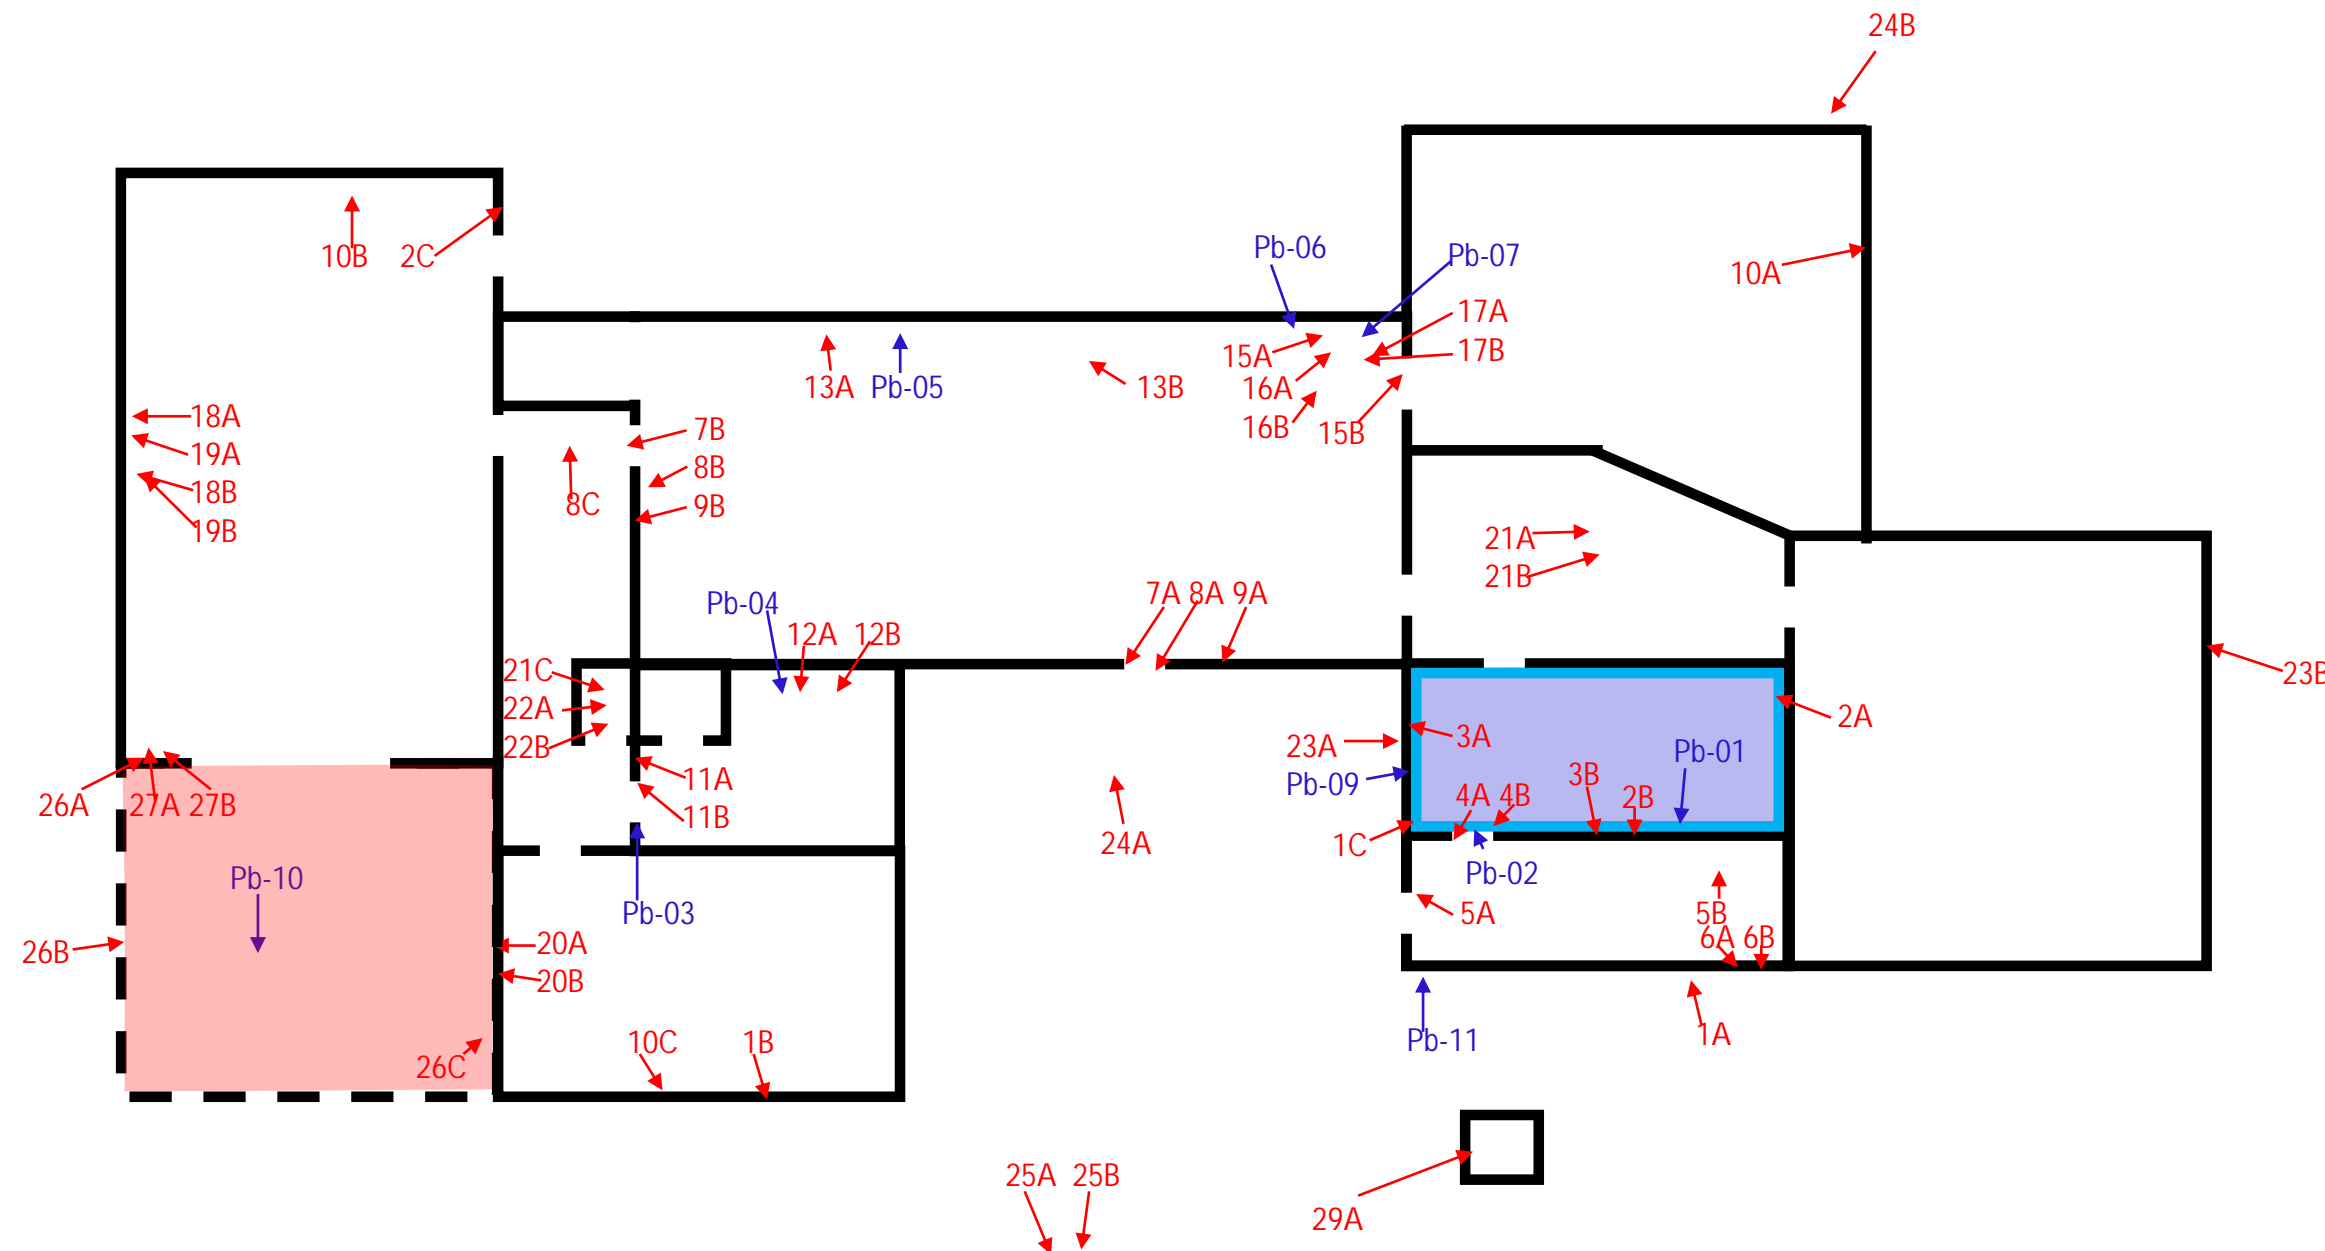
- Asbestos containing Gray Cementitious Material (<0.25% CH) associated ceramic wall tile system and drywall system (2% CH)
- Asbestos containing Gray Mortar and Gray Cementitious Material (<1%CH) associated with the ceramic floor tile system
- Lead containing 4" pink ceramic wall tile (4,790 ppm)
- Lead containing red paint (117 ppm) on concrete porch.

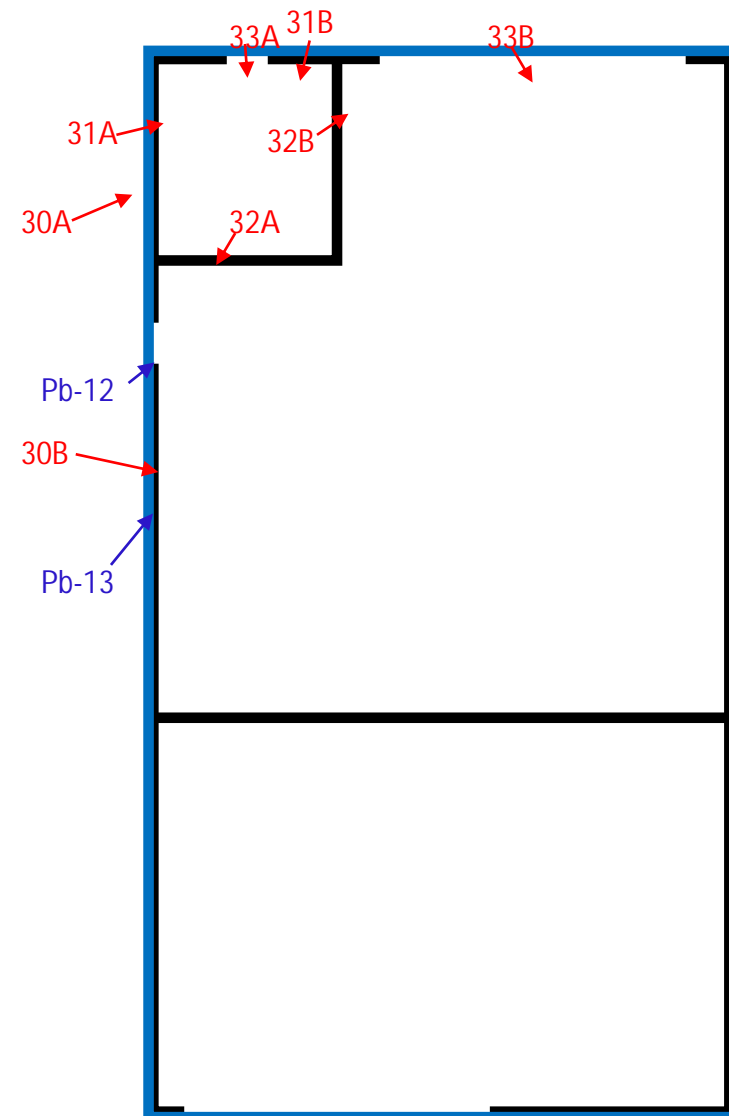
Asbestos was not detected in the sampled materials.

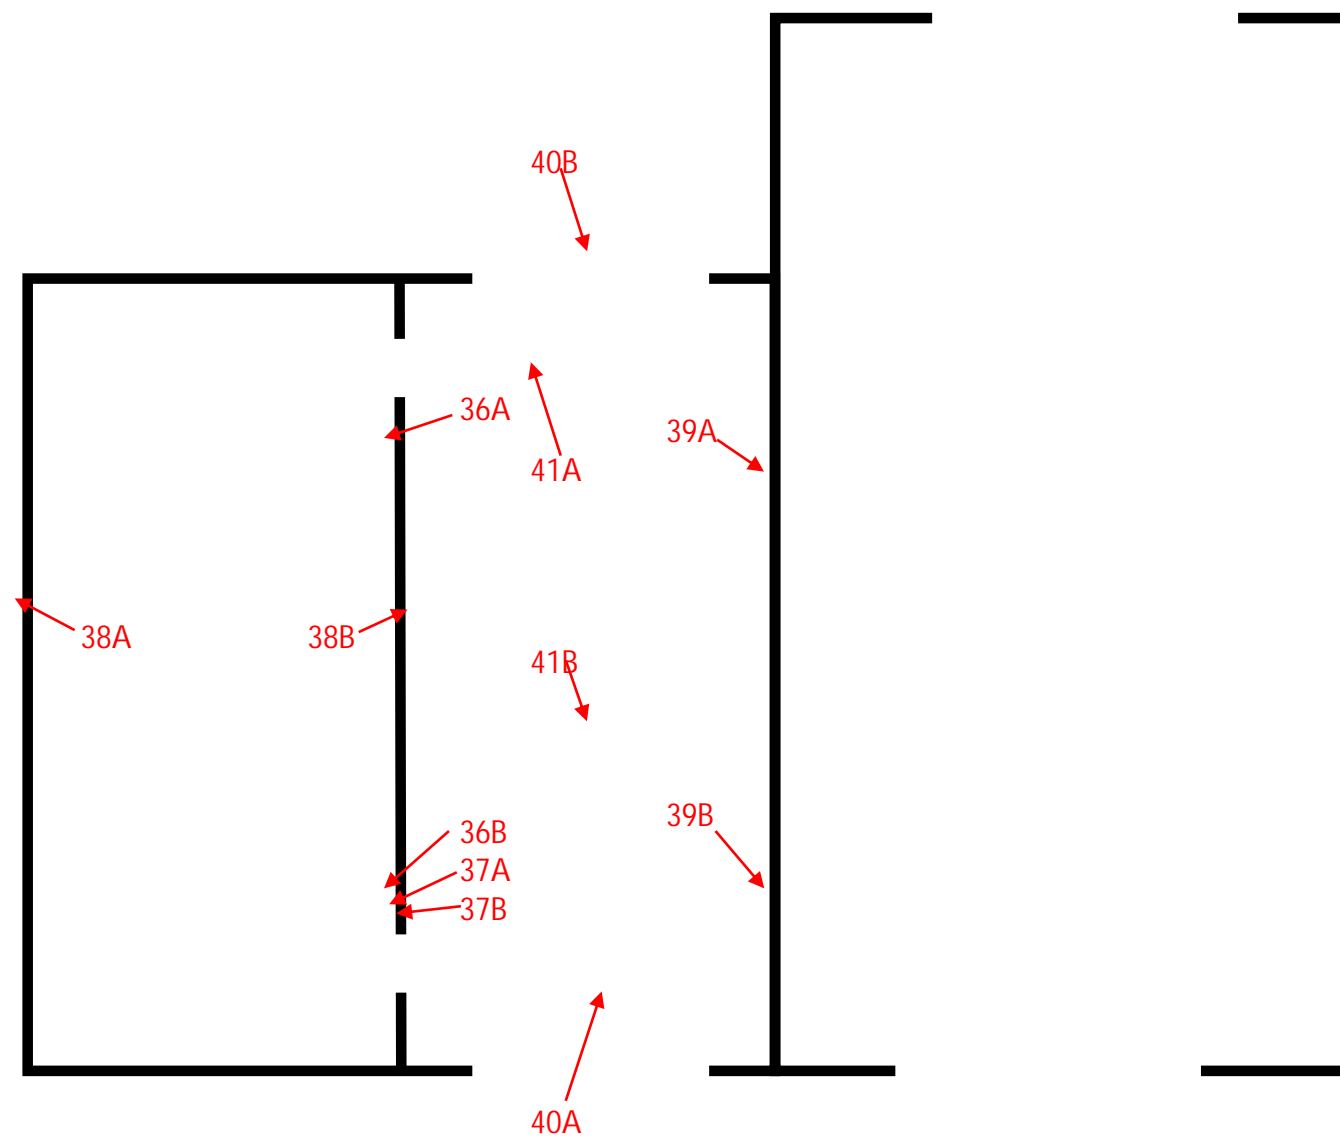
Asbestos was not detected in the sampled materials.
Lead was not detected in the sampled materials above the laboratory detection limit.

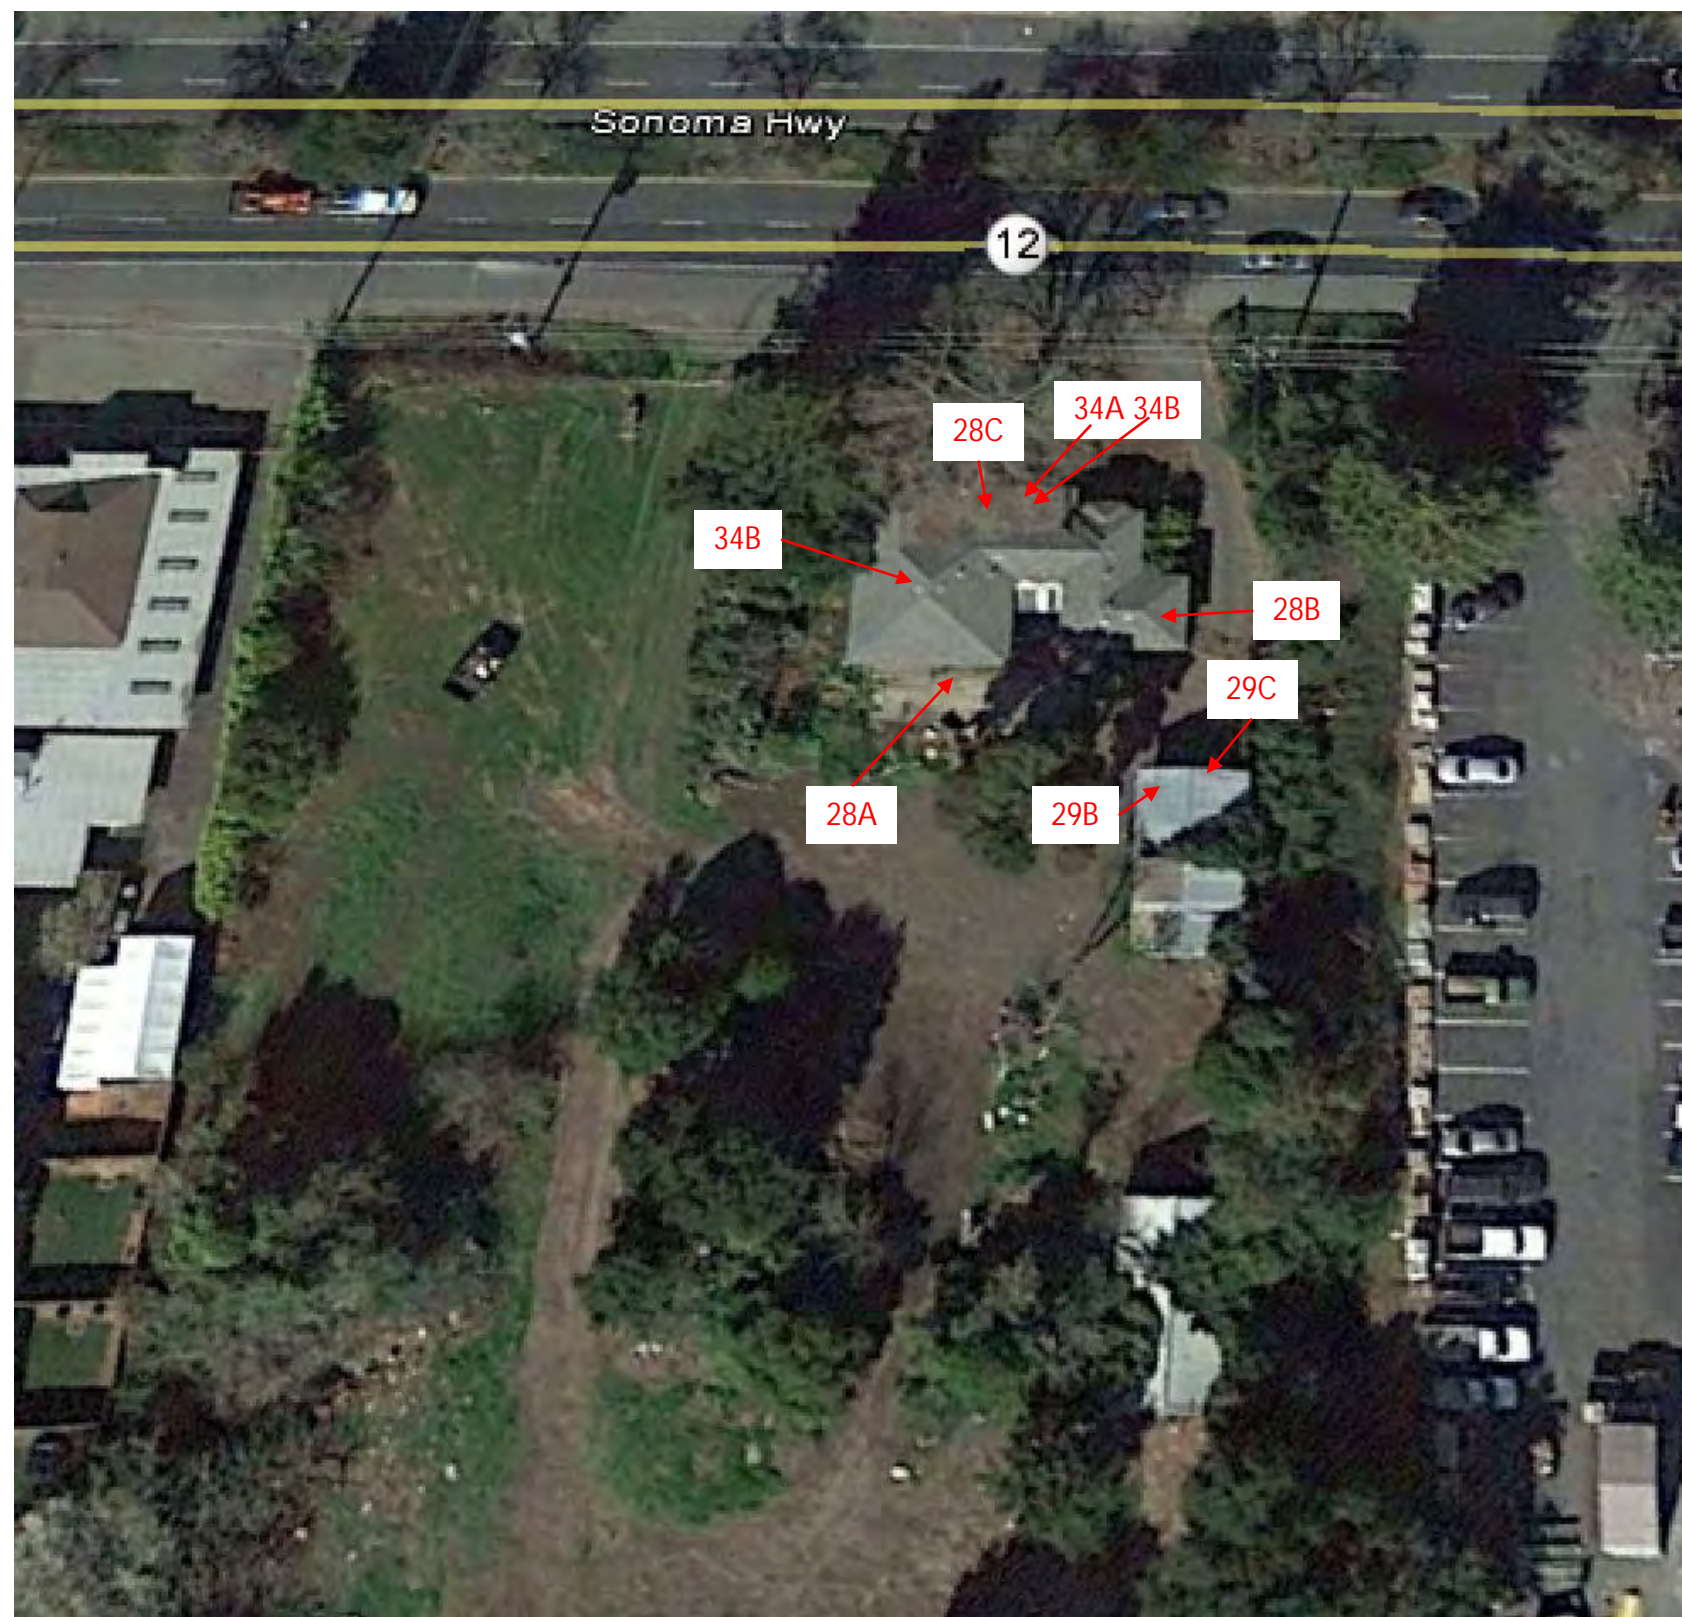
Asbestos was not detected in the sampled materials.
Lead was not detected in the sampled materials above the laboratory detection limit.
